## Andrology and Fertility

## Malfunctioned and Fractured Penile Prosthesis Caused by Cross Placement: Case Report

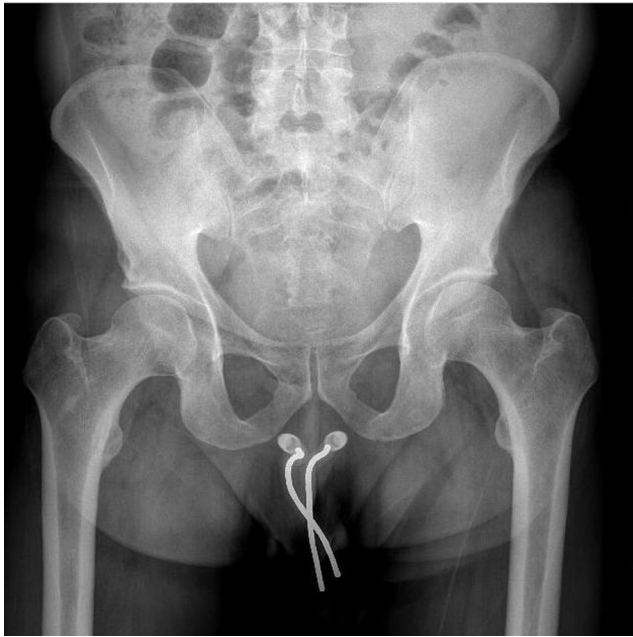
that the prostheses progress crossly and 1 cm distally from the root of the penis. The patient's laboratory values were normal. Pelvic radiography demonstrated that the penile prosthesis has been placed crossly (Fig. 1). The patient was prepared for surgery. A broad spectrum antibiotic treatment was initiated. The patient was operated. It was seen during the operation that the prosthesis placed on right corpus cavernosum has torn the right corpus cavernosum and passed through the left corpus cavernosum (Fig. 2). Furthermore, it was also observed that one of the prostheses was fractured (Fig. 3). The prostheses were removed. Any postoperative complication has not occurred in the patient. He was discharged. The patient was called 3 months later. The patient was prepared for surgery and again implanted malleable penile prosthesis. A penile prosthesis of 17 cm was placed on the left corpus cavernosum and 16 cm on the right corpus cavernosum. The patient who has not displayed any postoperative complication was discharged on the third day.

**Figure 1.** Preoperative X-ray graphy.

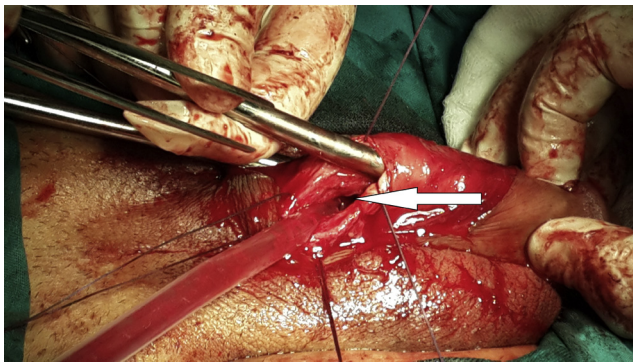
**Figure 2.** Intraoperative iatrogenic cavernosum rupture.

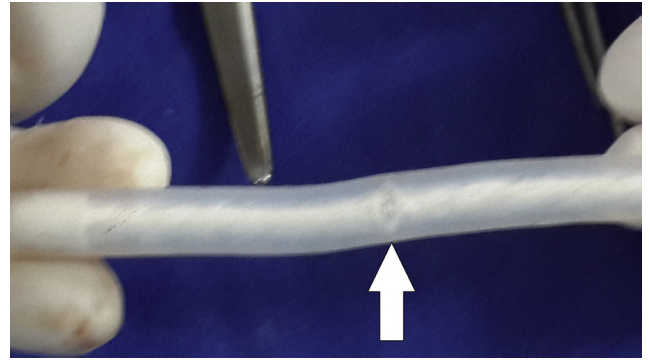
**Figure 3.** Broken prosthesis.
